Borehole rehabilitation

Borehole Engineering Services [BES] the borehole maintenance division of Drilcorp was recently commissioned by a specialist hydrogeological Consultant to overcome a biofouling problem on a major water production borehole.

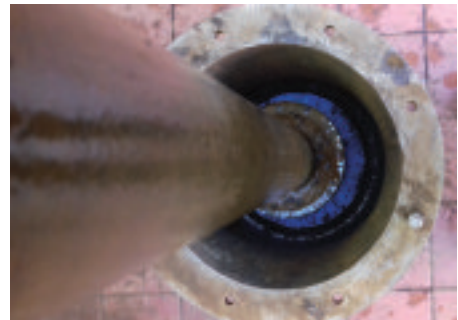
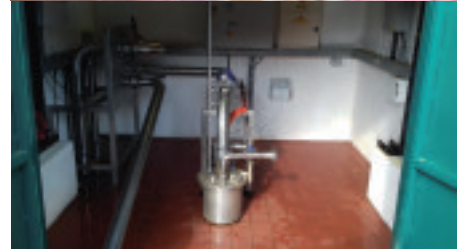
The submersible pump and rising main were removed and they once again were coated in a thick red-brown layer of biofilm. The borehole was scrubbed and airlifted to the top of the drop set casing. The 50mm pipe with the bent leading length was lowered and entered into the drop set casing with the aid of the camera. Now inside of the drop set cas-

ing, the camera was lowered down the remainder of the borehole. At 214mtr the borehole was found to have filled up with debris and rust which was blocking most of the screened section.

An air lifting tube was now lowered into the 50mm pipe and the borehole was blasted with compressed air to remove this loose debris and to clean the screens. This operation was successful however the bottom 10mtr of the casing could not be cleaned as the debris had solidified and could not be removed using this technique. The Consultant confirmed that this small section was not important to the productivity of the borehole and instructed to halt this operation.
